Manhole Inspection Summary

Manhole # S33E__030MH

Insp Date: **8/5/08 9:14 AM**

Location Address: **rear 300 w fayette st**

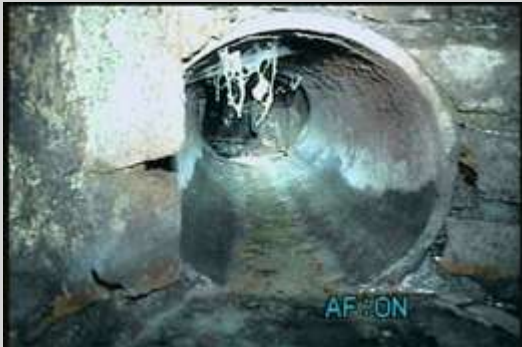
12 O'Clock Outflow

8 in. Circular Gravity Sewer
Pipe Out @ 12 O'Clock

Invert Depth: **16.66** (ft.) Flow Characteristics: **Slow**

Infiltration: **None** Pipe Seal Cond: **Unknown**

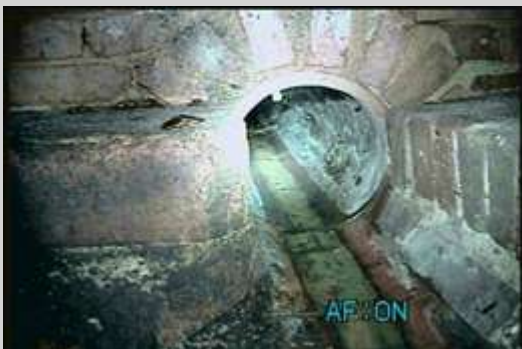
4 O'Clock Inflow

8 in. Circular Gravity Sewer
Pipe In @ 4 O'Clock

Invert Depth: **16.63** (ft.) Flow Characteristics: **Slow**

Infiltration: **None** Pipe Seal Cond: **Unknown**

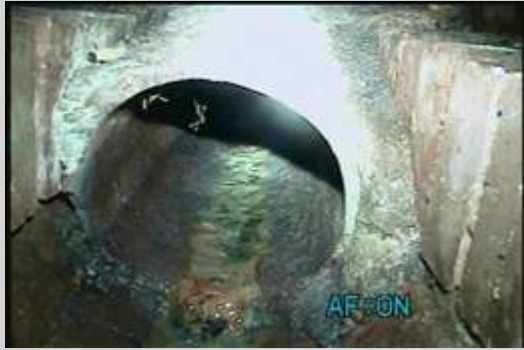
6 O'Clock Inflow

8 in. Circular Gravity Sewer
Pipe In @ 6 O'Clock

Infiltration: **None** Pipe Seal Cond: **Unknown**
